Surface Phenomena on Rhodium-Platinum Gauzes

CATALYST ACTIVITY DURING AMMONIA OXIDATION

By J. E. Philpott

Johnson Matthey Metals Limited

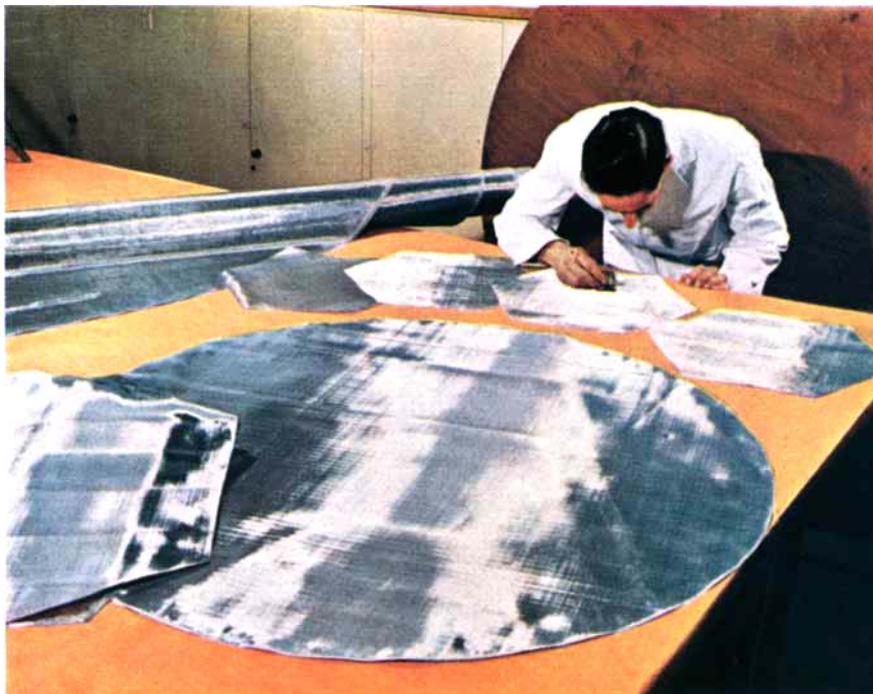
Fig. 1 Careful inspection of gauzes fabricated by Johnson Matthey Metals before dispatch to nitric acid plants. The flat circular gauze will be installed in a medium pressure plant and the smaller hexagonal gauzes in high pressure plants. The large rolled circular gauze will be installed in a plant operating at atmospheric pressure

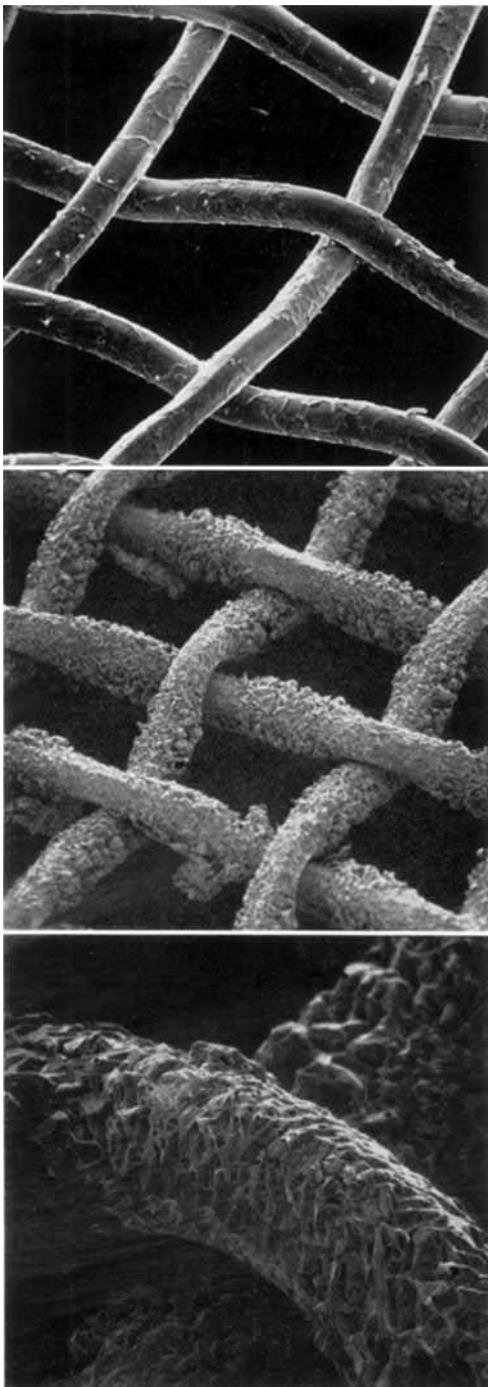
Fig. 2 10% Rh-Pt gauze wire 0.003 inch diameter in the as-drawn condition showing the uniform grain structure and absence of nodules on the wires

Fig. 3 The gauze of Fig. 2 after half the normal gauze life installed in a nitric acid plant showing the nodular pattern typical of an active gauze

Fig. 4 An enlarged view of the crossover point of two gauze wires from the gauze in Fig. 3 showing the octagonal crystal structure and the nodules, which are concentrated on the wire surfaces between crossover points

The photograph in Fig. 2 shows a gauze of 0.003 inch diameter wire with the wire in

installed in a nitric acid plant for half the normal gauze life period. Its surface shows the development of the nodular pattern typical of an active gauze. An enlarged view of the crossover point of two gauze wires from the same gauze is seen in Fig. 4. A clearly developed octagonal crystal structure can be seen in the enlargement and also the development of the nodules, which appear to be concentrated on the surfaces between the crossover points. Perhaps nodular growth at crossover points is inhibited by the slight movement of the wires that occurs while the gauze is in service. The structure seen here is generally typical of active gauzes whether they have been operated in low, medium or high pressure plants.

the as-drawn condition. The uniform grain structure and absence of nodules on the individual wires can easily be seen. Fig. 3 shows the same gauze after it has been

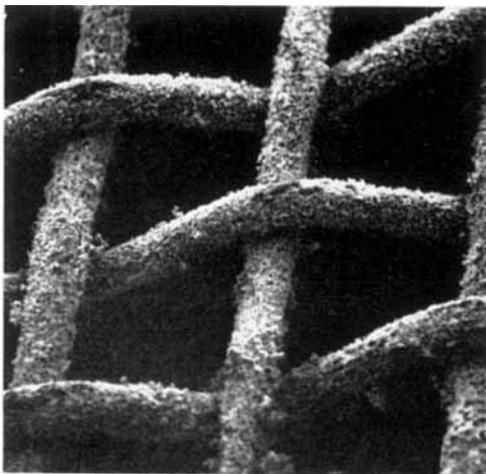
Fig. 5 An inactive gauze after a few days installed in a nitric acid plant showing the absence of octagonal crystal faces

When individual gauzes from an inactive pad are examined, a markedly different structure is observed. The regular development of octagonal crystal faces cannot be distinguished and an amorphous "cauliflower"-like growth as illustrated in Figs. 5 and 6 is seen, in contrast to the "brussels sprout" nodules usual on active gauzes.

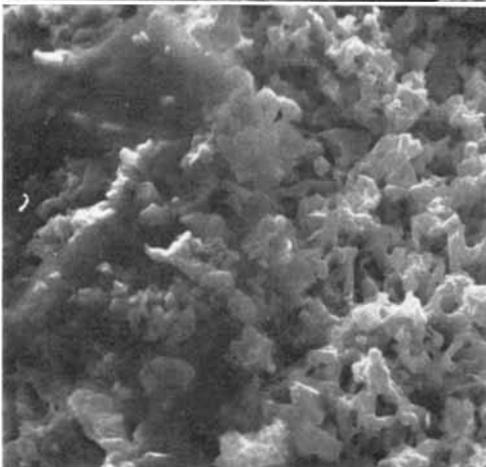
Fig. 6 An enlarged view of the gauze wire shown in Fig. 5 with the cauliflower-like amorphous growth characteristic of inactive gauzes

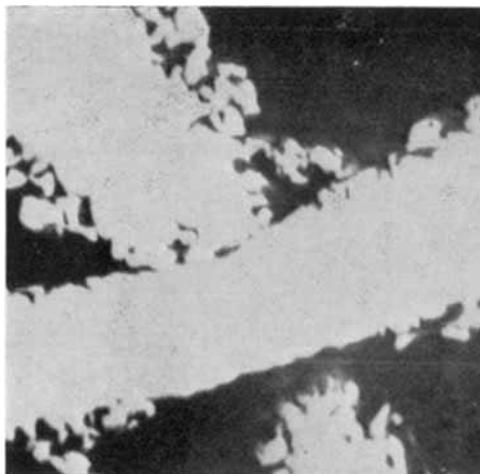
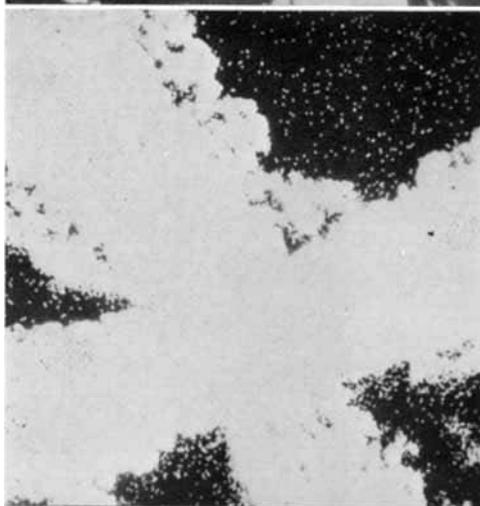
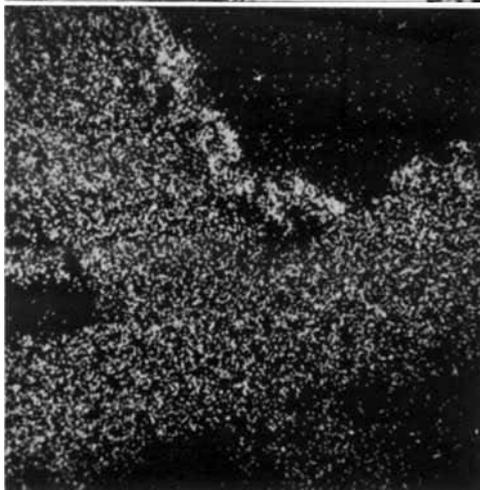
Fig. 7 (right) Electron and X-ray images of spent active gauze showing its homogeneity. a (top) Electron image of cross-section of gauze. b (middle) Pt M α X-ray image. c (bottom) Rh L α X-ray image. $\times 360$

Examination of the electron images from the active gauzes (Fig. 7) shows that the wires were homogeneous and no unusual features are visible. In the electron images of the inactive gauzes (Fig. 8) a clearly defined concentration of material is seen on the surface of the wires. This segregation on the

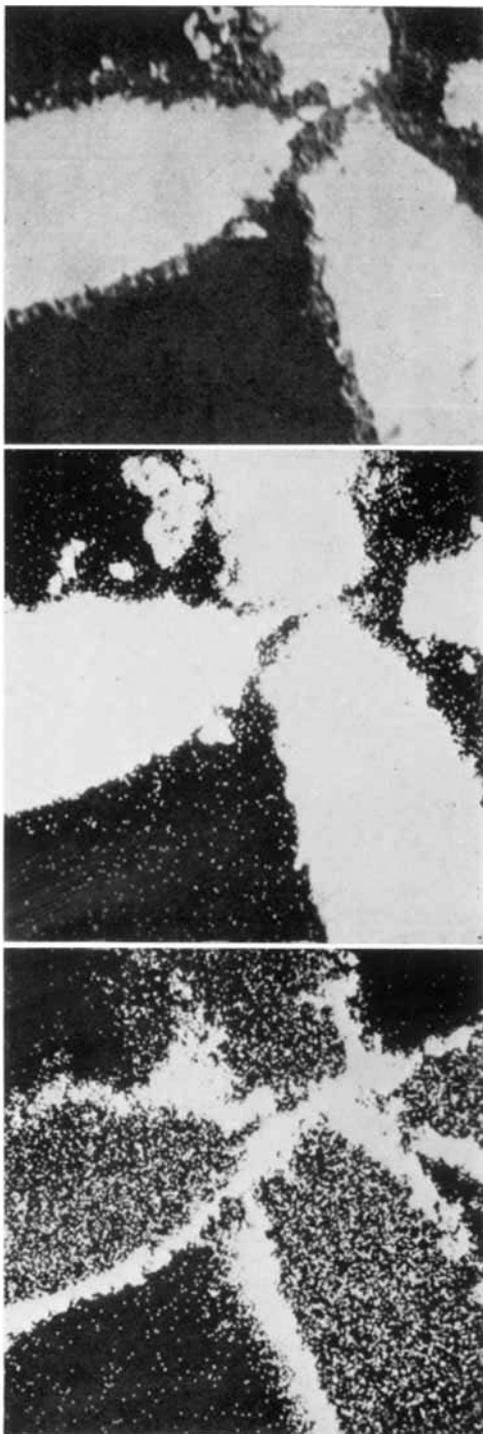
Fig. 8 Electron and X-ray images of spent inactive gauze showing segregation of material at the surface

a Electron image of cross-section of gauze

b Pt $M\alpha$ X-ray image

c Rh $L\alpha$ X-ray image

the effect is really due to the micro-section being a plane through the middle of the gauze so that more of the wire surfaces is visible at the crossover points where the wires dip and rise in crossing each other.

The composition of the material shown in Fig. 8c is very probably rhodium present as rhodium oxide Rh_2O_3 . A similar electron image was seen showing a concentration of iron, probably as Fe_2O_3 , which was associated with the surface concentration of rhodium. Neither of the active gauzes examined showed any sign of surface concentration of rhodium or iron oxides.

wire surface appears to be more marked at the crossover points but this is not so because

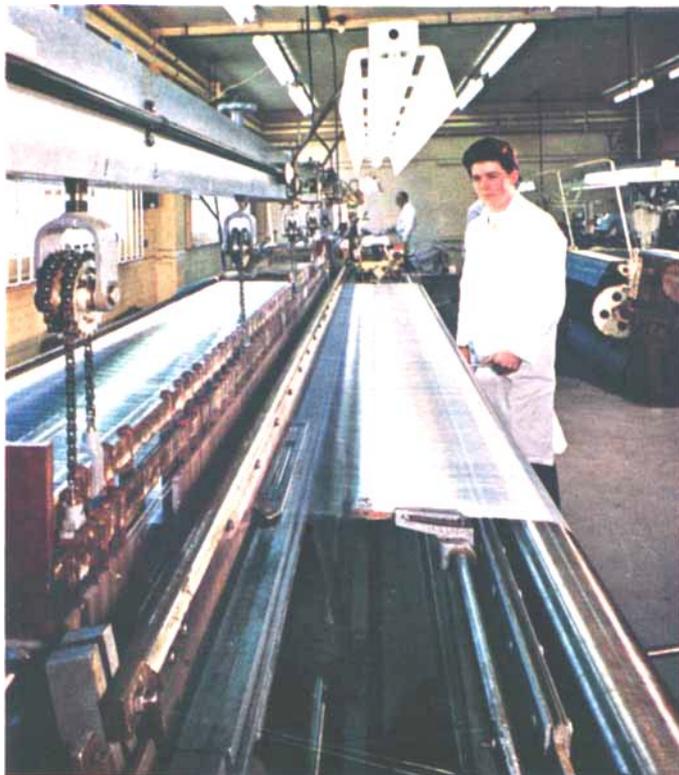
Fig. 9 Gauze fabrication on the looms in the Johnson Matthey Metals gauze shop. Rhodium-platinum gauzes up to 140 in (3.56 metres) wide are woven from 0.003 in diameter wire
